Project Description: Arcoplast Antimicrobial Concealed Hanger Ceiling System

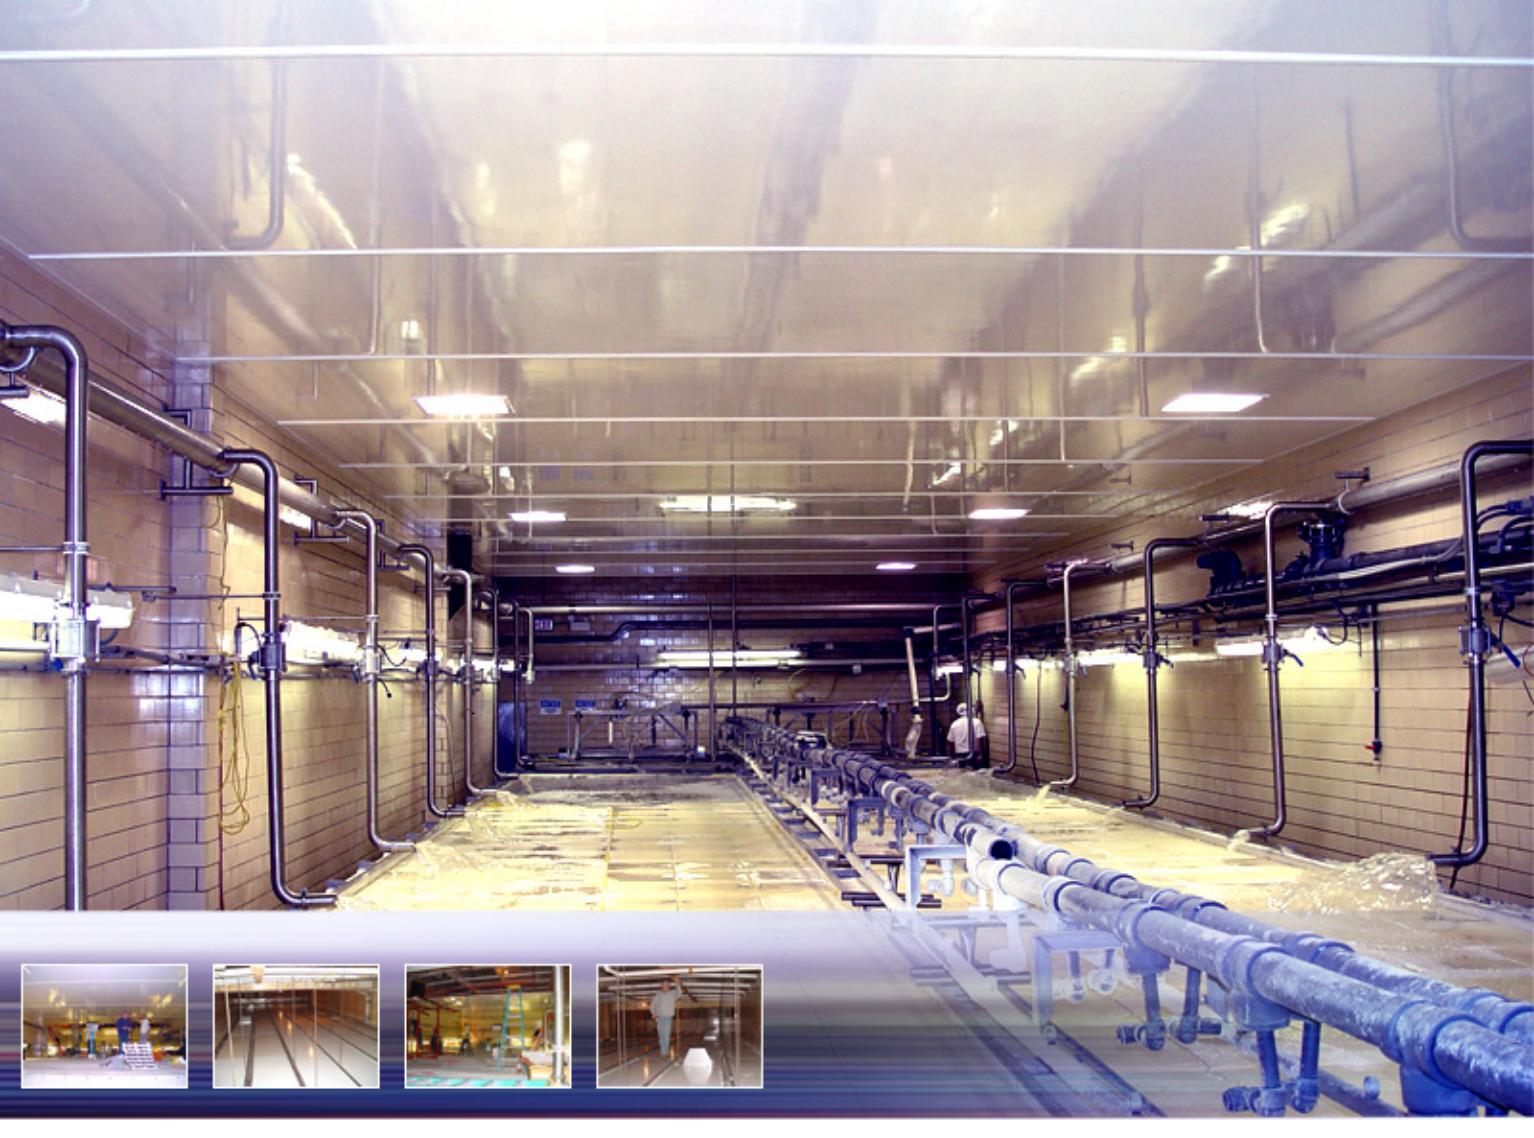
The ceiling we installed in the brine tank room and Stockton Cheese is one of the most challenging projects we have done so far. The room measured one-hundred six feet long, and twenty five feet wide. Centered in the room is a brine tank in which enormous blocks of cheese pass through as part of the brining process. The size of the tank created only an 18" walkway around the perimeter. Production operates 24 hours a day, 7 days a week creating an obstacle which cannot be moved or disturbed. A plan had to be formulated to install the ceiling during production. Custom narrow scaffold was built to make a perimeter around the tank. I-beams were used as plank on top of the scaffolding, and then 2' wide plank were placed on top of the I-beams, creating a mezzanine above the tank. Rolls of poly sheeting and tarps were placed on the mezzanine to ensure that nothing would fall into the tank from the work being done above.

Once the false floor was installed above the tank, work proceeded as normal. A slot was cut above the ceiling height to bring panels into the room and then walked down into place. Stainless steel was used for all rods, hangers, and hardware above the ceiling due to the tremendous amount of salt in the air. A lot of careful planning and coordination went into making this extremely difficult project a success.
